WETLAND DELINEATION

**340-ACRE TRACT
SOUTH OF INTERSECTION OF
INTERSTATE 69 & STATE ROAD 56
PETERSBURG, INDIANA
PROJECT NO.: 16IN0310**

**Alt & Witzig Consulting Services
Carmel, Indiana**

**June 22, 2016
Revised August 1, 2016**

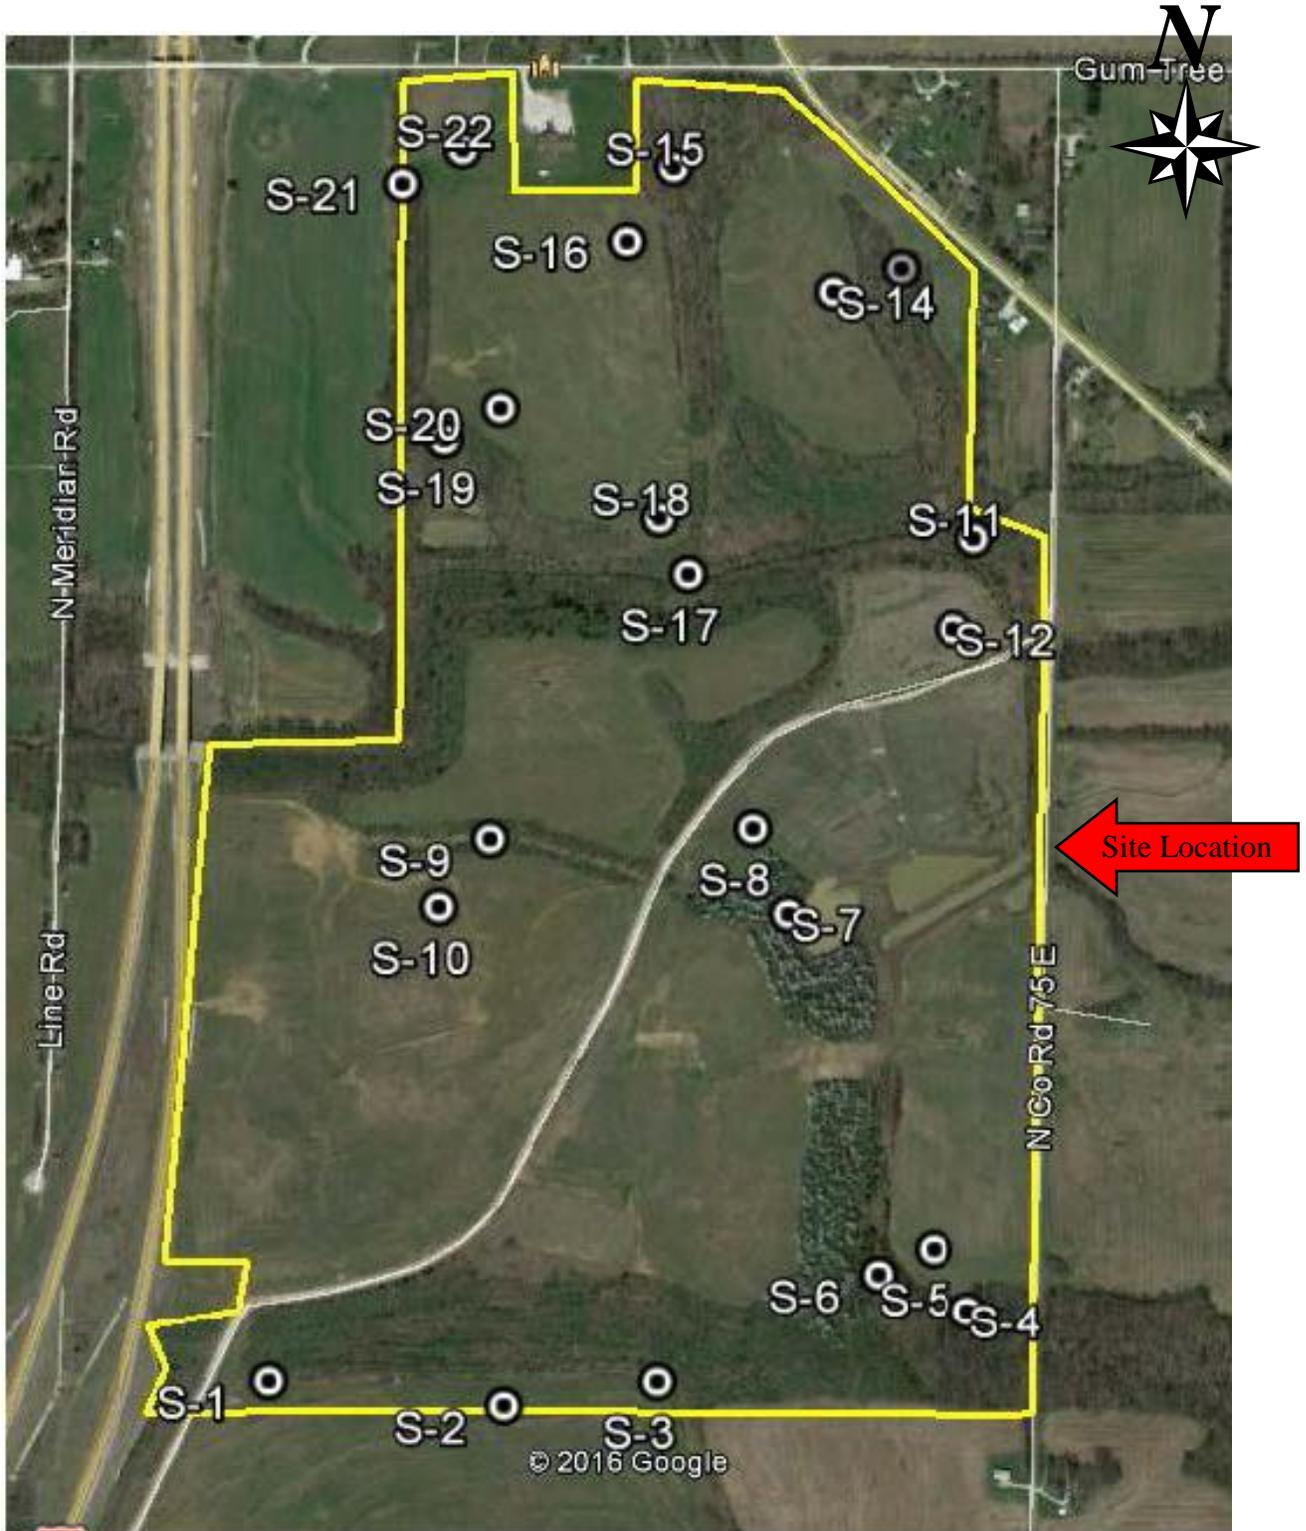
FIGURE 2: SAMPLE LOCATION MAP

A dominance of wetland/hydrophytic vegetation was observed at sample points S-1, S-3, S-4, S-6, S-7, S-9, S-11, S-13, S-15, S-17, S-19 and S-21. These twelve (12) sample points were all located within wooded areas throughout the Site. Hydrophytic vegetation appears to be the dominant form of vegetation within the wooded tracts, specifically within the vicinity of drainage features and/or open water features. However, it should be noted that the majority of the Site was formerly involved in surface mining operations. These areas that were formerly surface mined appear to have been replanted manually, as was evidenced by the distinct rows of trees and grasses in these areas. In addition, some of the observed hydrophytic species (i.e. *Phragmites australis* and *Phalaris arundinacea*) are considered to be invasive by the Indiana Department of Natural Resources. Therefore, the vegetation located within the formerly surface mined areas throughout the Site is potentially problematic. The vegetation located in areas not within wooded tracts or on hills/hillsides was observed to consist primarily of upland species.

The Site was investigated for the presence of wetland hydrology and/or hydrological indicators noted in the USACE Midwest Regional Supplement. Wetland hydrology was observed at sample points S-1, S-3, S-4, S-6, S-7, S-9, S-11, S-13, S-15, S-17, S-19 and S-21. These twelve (12) sample points were all located within wooded areas throughout the Site. Wetland hydrology was not observed in the vicinity of the remaining sample points.

Hydric soil indicators were observed at sampling points S-1, S-3, S-4, S-6, S-7, S-9, S-11, S-13, S-15, S-17, S-19 and S-21. These twelve (12) sample points were all located within wooded areas throughout

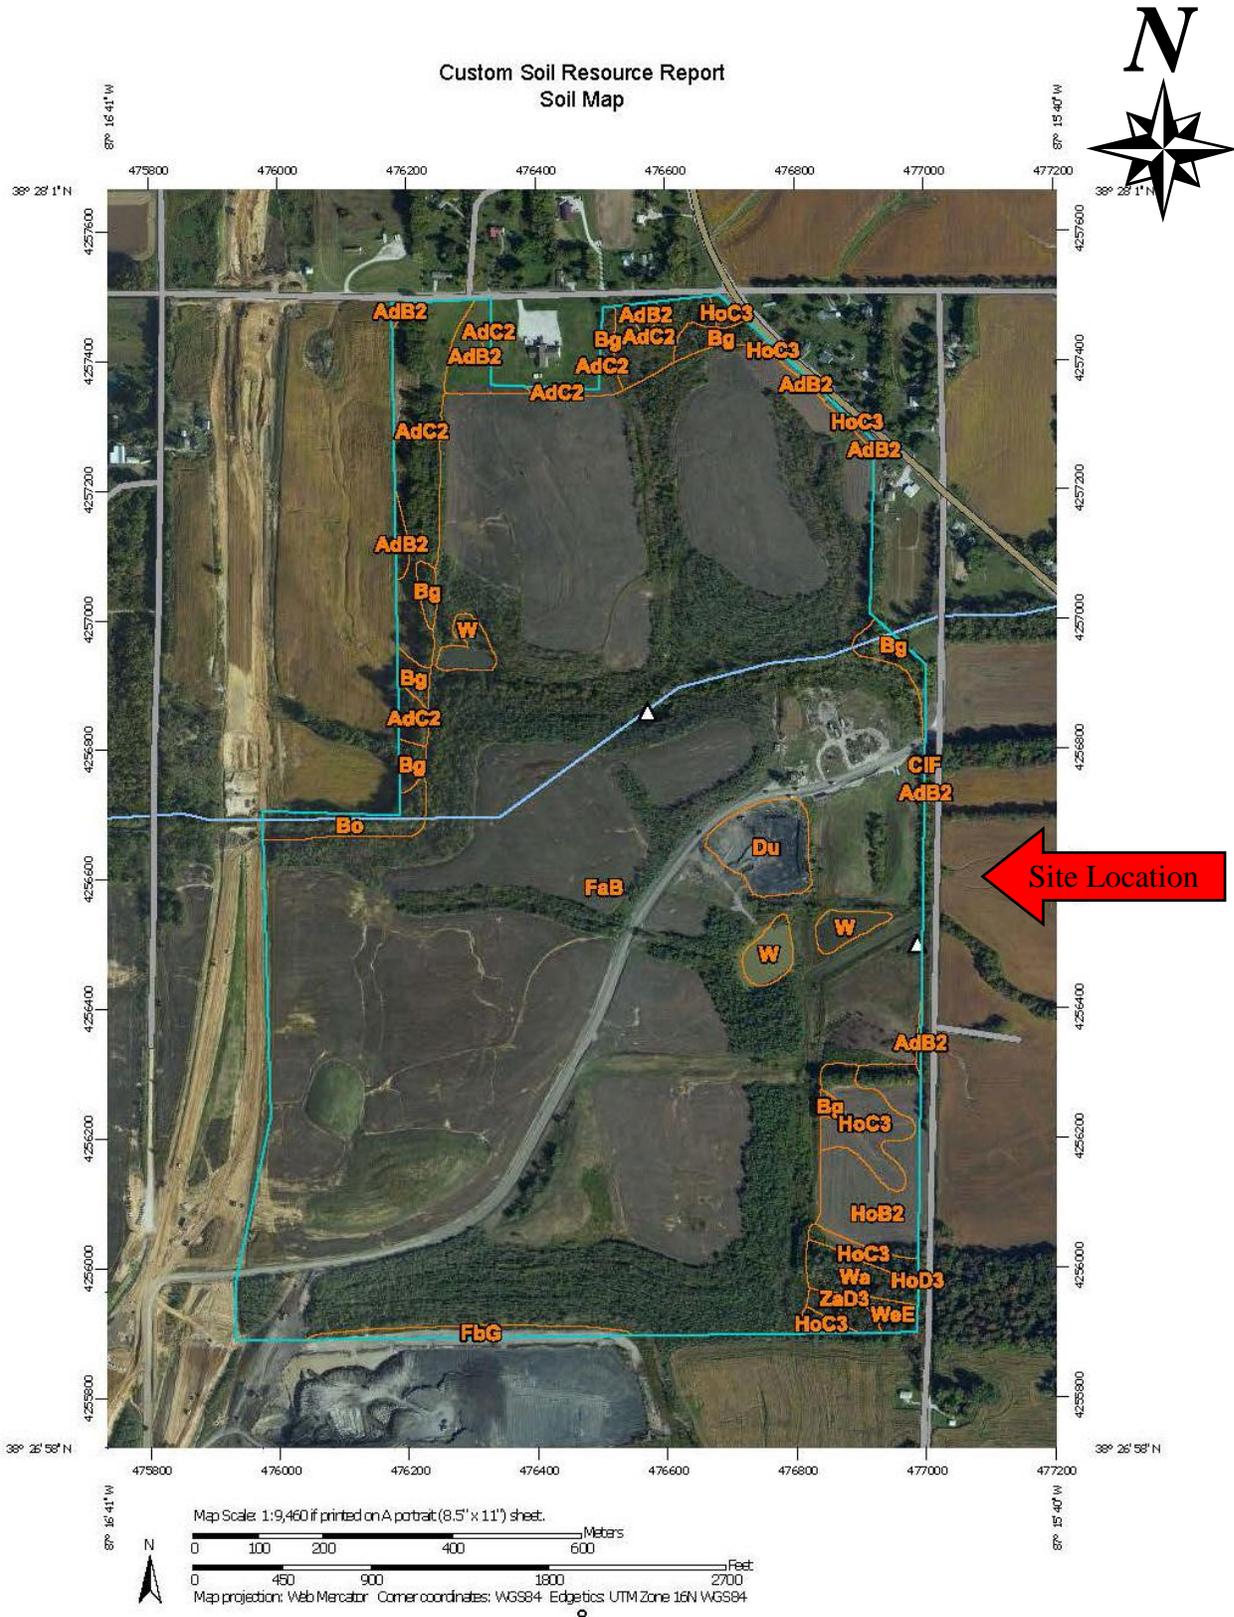
FIGURE 3: SOIL MAP

A custom soil report for the Site was generated using the USDA web soil survey (Appendix C). Based on the report, it appears thirteen (13) soil associations are present on the Site (Appendix A, Figure 3). All thirteen of the soil associations at the Site are classified as hydric. It should be noted however, that soil surveys act as a guide to the general types of soil in an area and field observations take precedent.

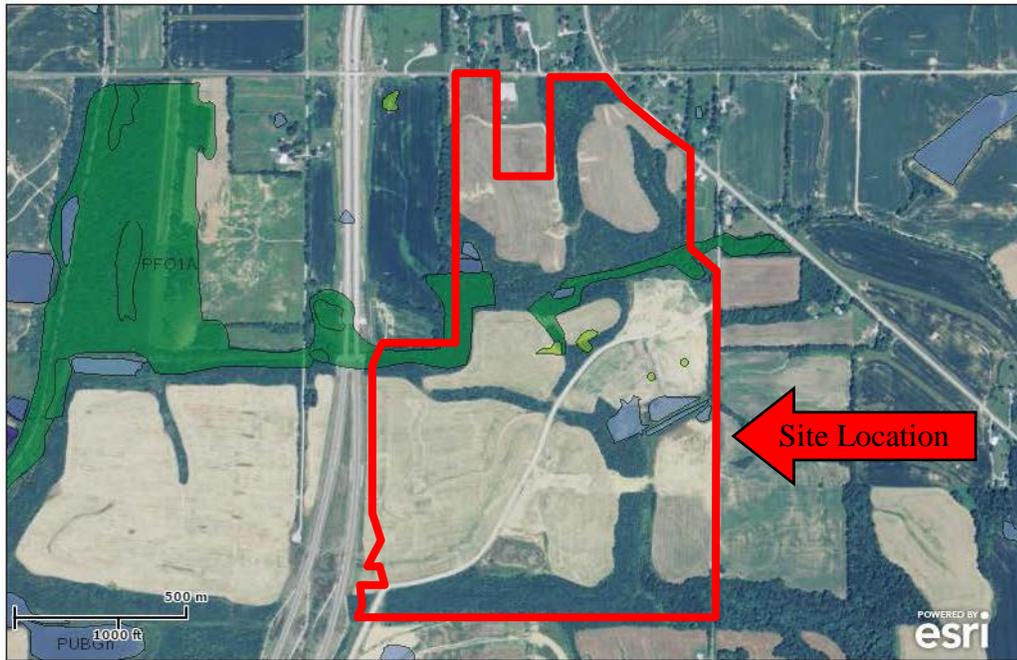
U.S. Fish and Wildlife Service
National Wetlands Inventory

An NWI map was reviewed for the Site (Figure 4, Appendix A). The NWI map depicted two (2) "Forested/Shrub" wetlands on the central portion of the Site, four (4) "Emergent" wetlands on the central and eastern portions of the Site, and seven (7) "Freshwater Ponds" on the eastern and central portions of the Site. It should be noted the NWI map does not preclude the results of a wetland assessment.

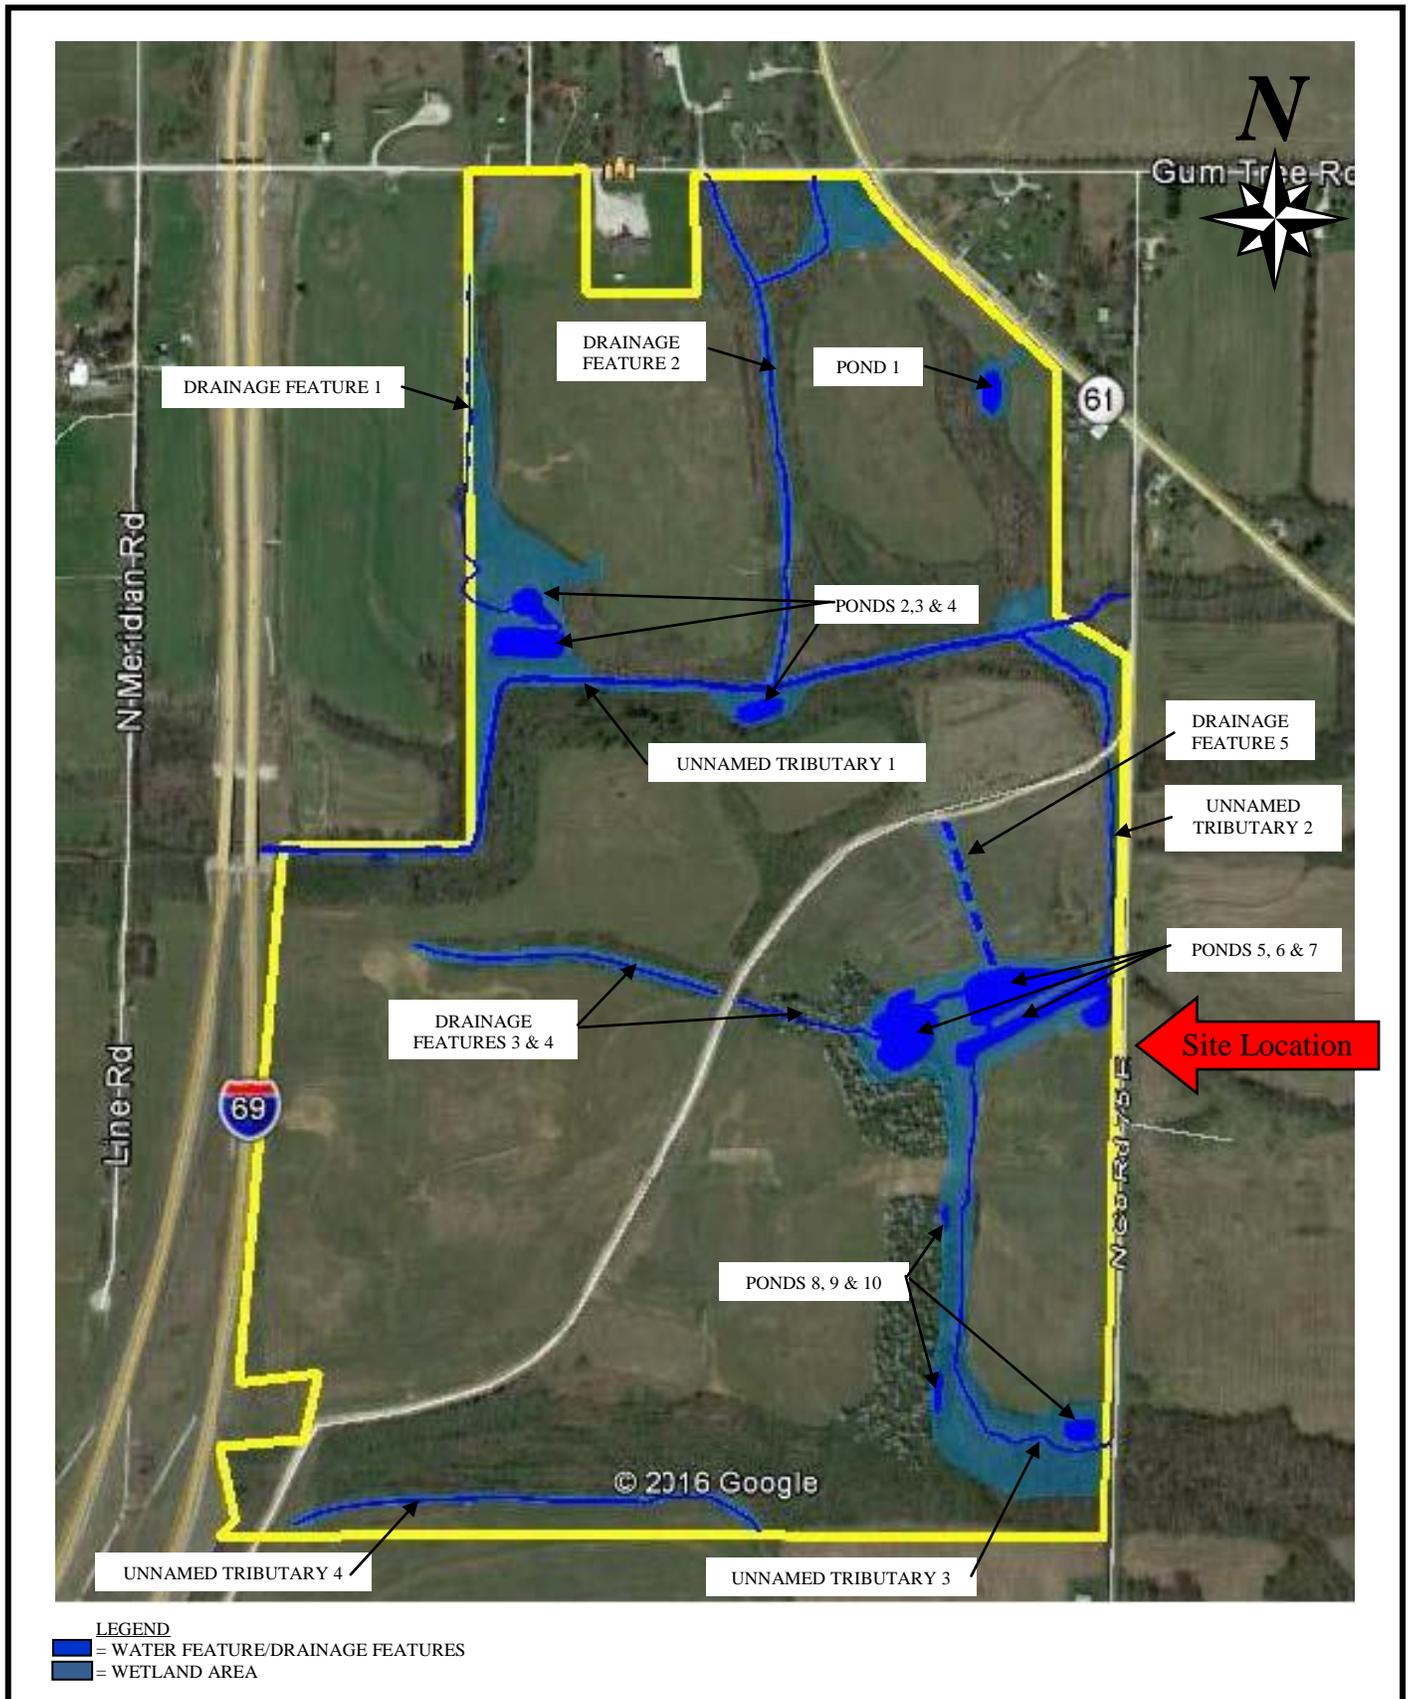
FIGURE 5: WETLAND MAP

Based on this reconnaissance, four (4) unnamed tributaries, ten (10) ponds/open water features and five (5) drainage features were identified on the Site. Wetland areas were observed to be located within the vicinity of the ponds/open water features, unnamed tributaries and drainage features. (see Figure 5, Appendix A).

As previously stated, wetland areas were observed to be located surrounding the on-Site tributaries, ponds and drainage features. These wetland areas totaled approximately 55-acres, cumulatively. Wetland boundaries were marked with pink biodegradable marking tape using a handheld GPS device for the purpose of approximating the boundaries and sizes of the identified wetlands. However, wetland boundaries were not surveyed as a part of this assessment. All wetland areas, with the exception of wetland areas adjoining Pond 1, are anticipated to be regulated by the USACE as "Waters of the U.S."

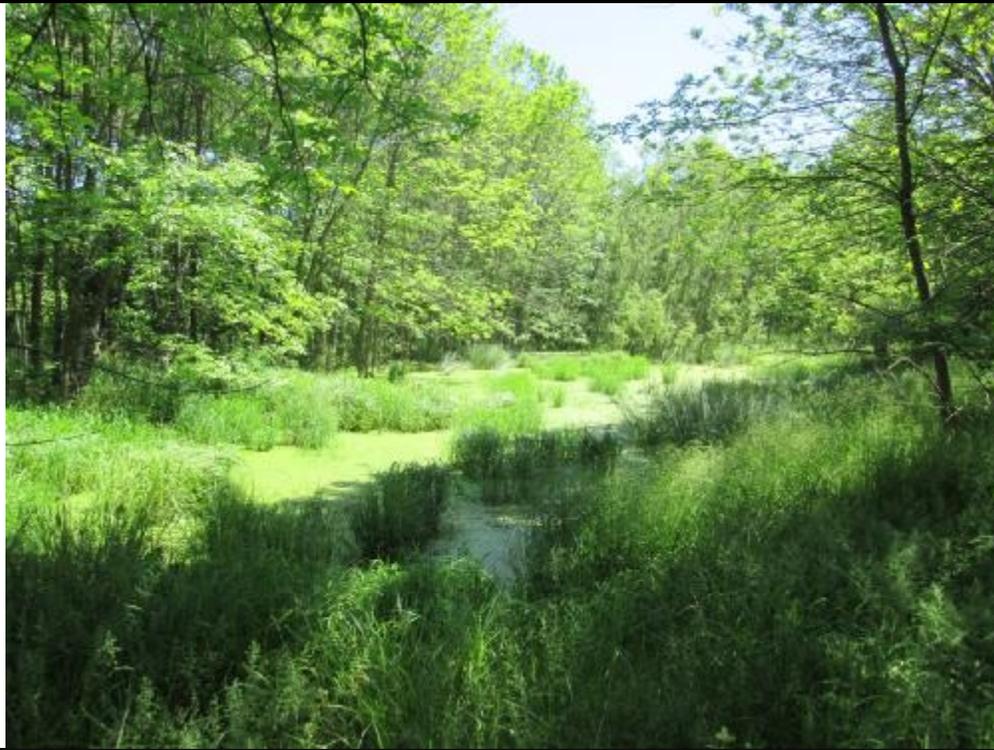
Pond 1 is located on the northeastern portion of the Site, is approximately 0.10-acres in size and is situated within a wooded tract. This pond has been located on the Site since at least 1998 and appears to have formed as drainage, originating from adjoining upland areas to the west and a culvert from the northeast, consistently inundated this portion of the Site. Fringe wetland areas were observed to surround Pond 1 and extended toward the northeast and the culvert situated underneath State Road 61. Based on observations made during the Site reconnaissance and a review of the Petersburg, Indiana USGS 7.5-Minute Series Topographic map, it is Alt & Witzig's opinion that this pond and the fringe wetland areas appear to be isolated and do not contain a significant nexus to a "Waters of the U.S."

Photograph # 1	Description: Viewing Pond 1 located on the northeastern portion of the Site.	
Project # 16IN0310	Project Name: 340-Acre Tract	Date: 5/17/2016

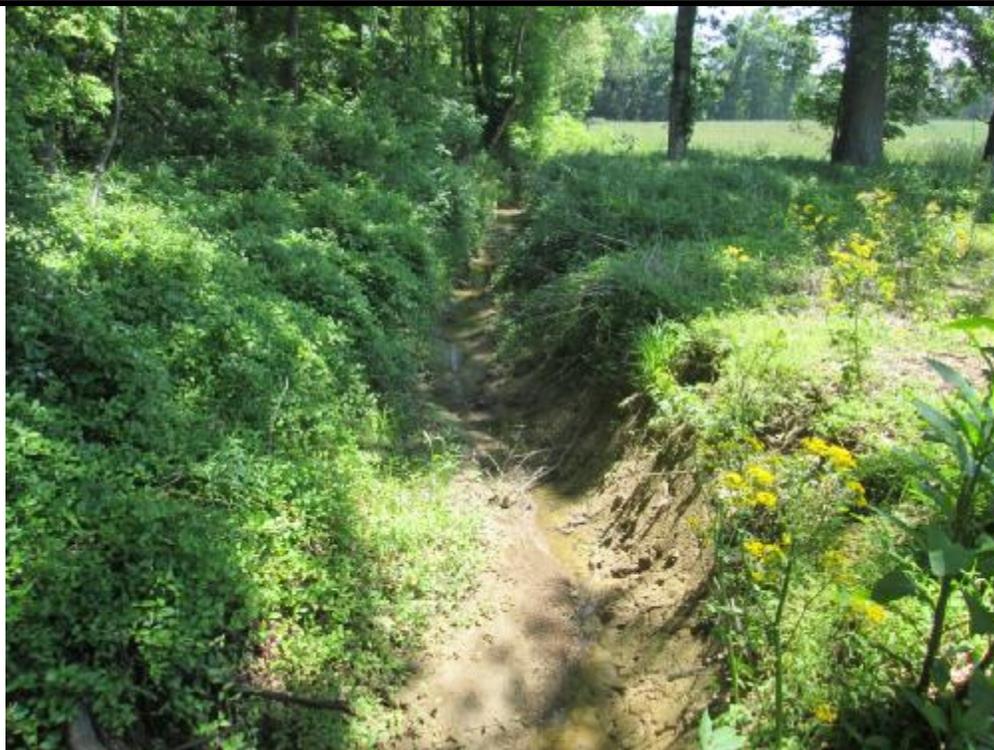
Drainage Feature 1 traverses the northwestern Site boundary from north to south. Observations made during the Site reconnaissance indicated that water originating from precipitation events collects from the adjoining upland areas to the east, north and west and flows in a southerly direction toward Ponds 2 and 3. Fringe wetland areas were observed to be located along Drainage Feature 1. As stated previously, it is Alt & Witzig's opinion that Ponds 2 and 3 contain a significant nexus to a "Waters of the U.S.". In addition, Drainage Feature 1 demonstrated an OHWM and defined bed and bank. Therefore, Drainage Feature 1 and the fringe wetland areas are anticipated to be regulated by the USACE as "Waters of the U.S."

Photograph # 2	Description: Viewing Drainage Feature 1 located on the northwest portion of the Site.	
Project # 16IN0310	Project Name: 340-Acre Tract	Date: 5/17/2016

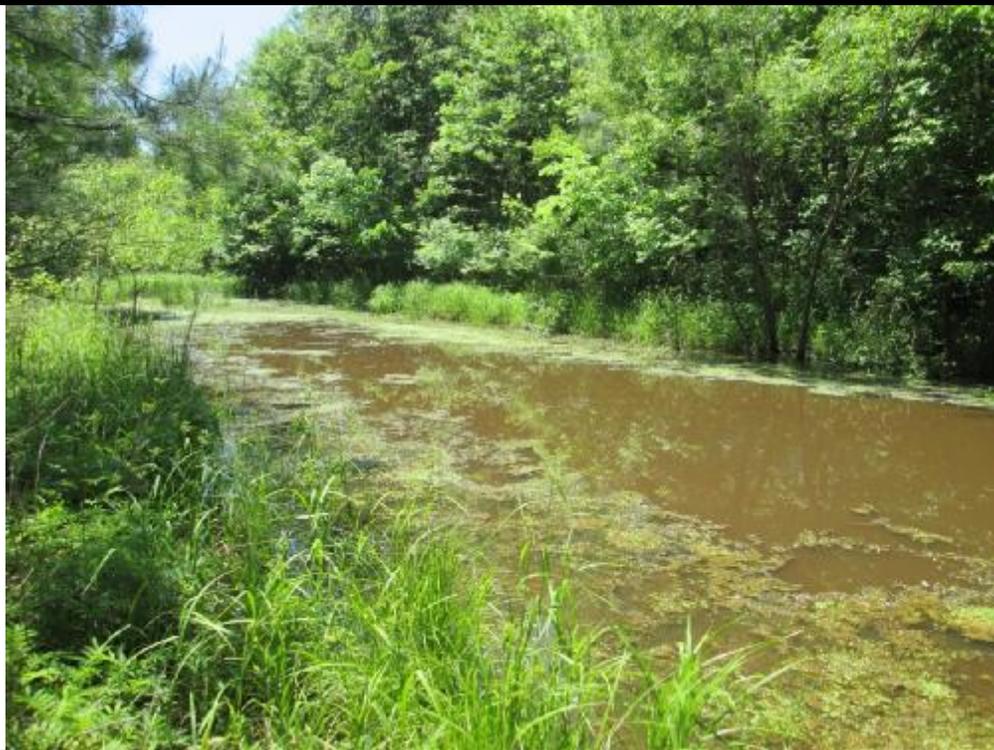
Photograph # 4

Ponds 8, 9 and 10 are located on the southeast portion of the Site and are approximately 0.08-acres, 0.1-acres and 0.03-acres in size. A review of historical aerial photographs indicated that Ponds 8 and 9 have been located on the Site since at least 1998 and appear to have formed as a result of former surface mining operations. A review of historical aerial photographs and the Petersburg, Indiana USGS 7.5-Minute Series Topographic map indicated that Pond 10 has been located on the Site since at least the early 1960s. Fringe wetland areas were observed to surround Ponds 8, 9 and 10 in all directions. Observations made during the Site reconnaissance indicated that it is likely excess water from Ponds 8, 9 and 10 drains to Unnamed Tributary 3, which converges with Pond 7. As stated previously, it is Alt & Witzig's opinion that Pond 7 contains a significant nexus to a "Waters of the U.S."; therefore, Ponds 8, 9 and 10 and the fringe wetland areas are anticipated to be regulated by the USACE as "Waters of the U.S."

Description: Viewing Pond 9 located on the southeast portion of the Site.

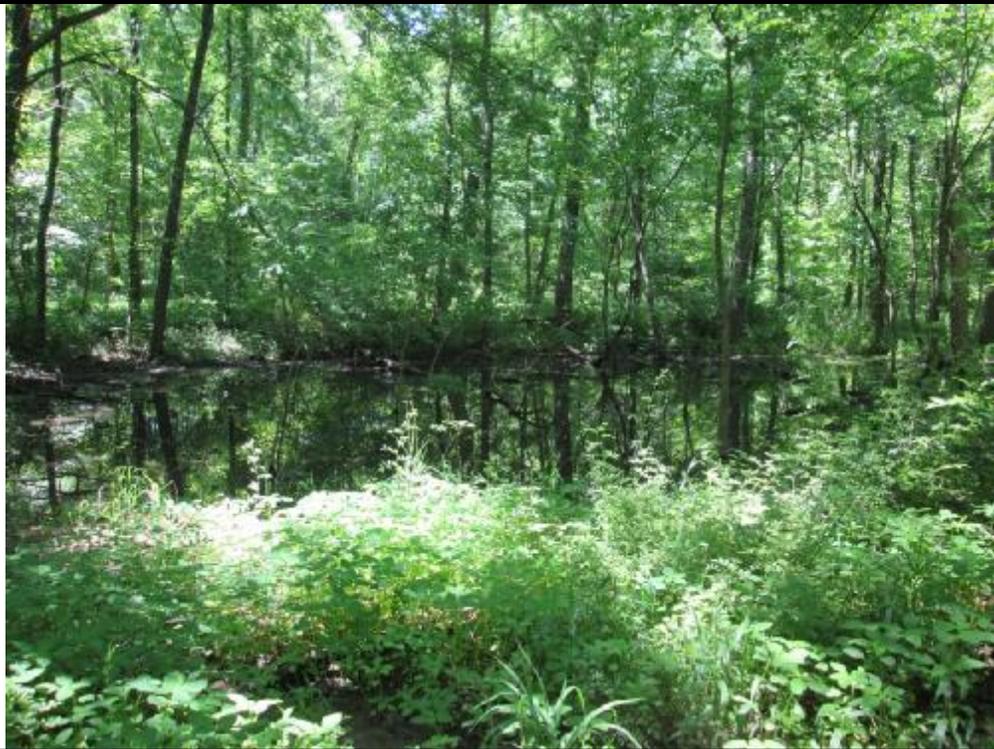
Photograph # 7

Description: Viewing Pond 10 located on the southeast portion of the Site.

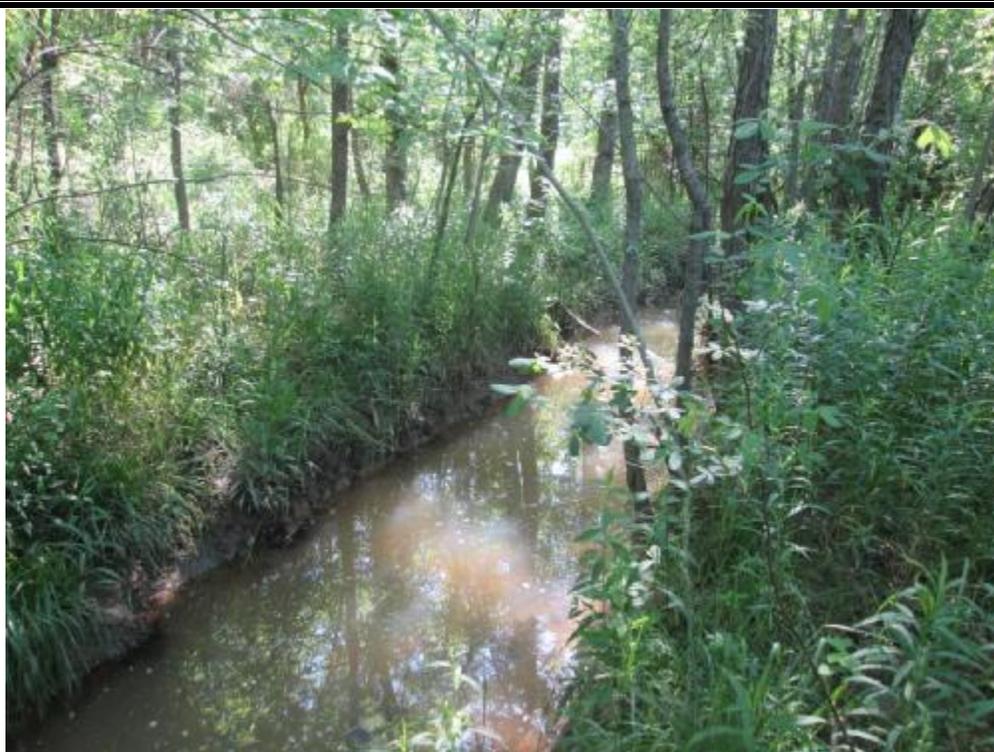
Photograph # 8

Unnamed Tributary 4 traverses the southwestern portion of the Site from west to east, totaling approximately 1,900-linear feet. This unnamed tributary has been located on the Site since at least 1998. A review of historical aerial photographs indicated that this unnamed tributary was likely created as a result of former surface mining operations that occurred on and off-Site. Fringe wetland areas were observed to be located along Unnamed Tributary 4. Unnamed Tributary 4 appears to originate approximately 0.6-miles southeast from the Site and emerges from a wooded area. The section of Unnamed Tributary 4 located on the Site was observed to be flowing in a westerly direction. Unnamed Tributary 4 continues to flow off-Site in a westerly direction until it converges with Prides Creek. Prides Creek continues to flow in a northerly direction until it eventually converges with the White River. Unnamed Tributary 4 demonstrated an Ordinary High Water Mark (OHWM), a defined bed and bank and a significant nexus to a Traditional Navigable Water (TNW); therefore, Unnamed Tributary 4 and all fringe wetland areas are anticipated to be regulated by the USACE as a "Waters of the U.S."

Description: Viewing Unnamed Tributary 4 located on the southern portion of the Site.

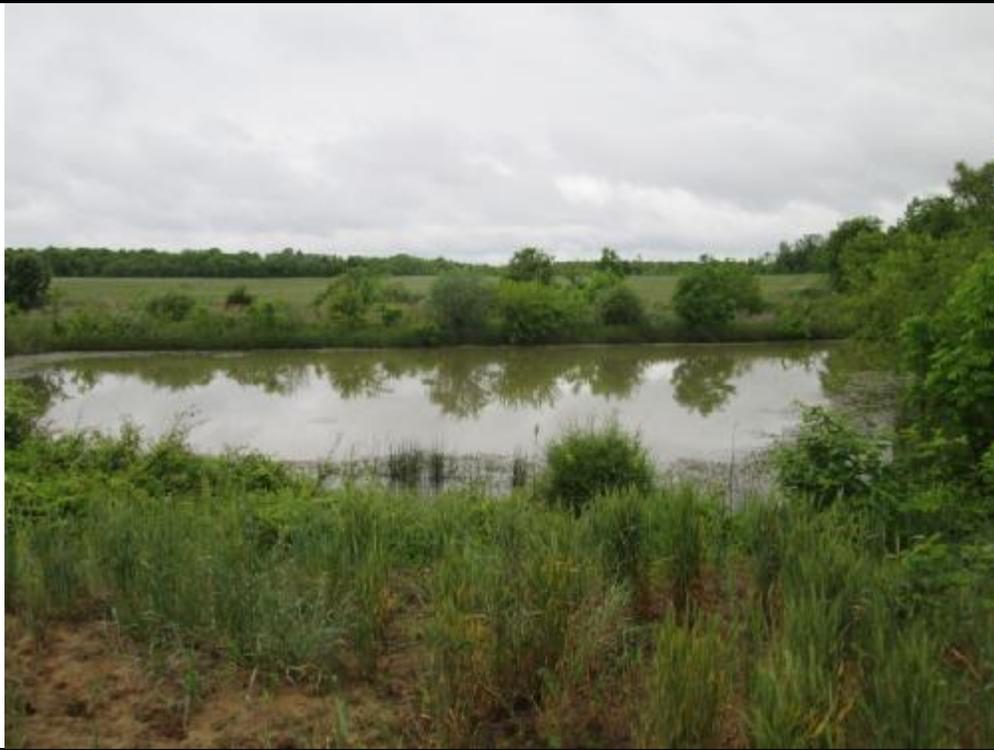
Ponds 5, 6 and 7 are located on the eastern portion of the Site and are approximately 1.6-acres, 1.3-acres and 1.15-acres in size. These three ponds have been located on the Site since at least 1998 and appear to have formed as a result of former surface mining operations. Ponds 5, 6 and 7 were observed to be connected via a series of channels. Fringe wetland areas were observed to surround Ponds 5, 6 and 7 in all directions. Observations made during the Site reconnaissance indicated that Pond 7 connects to Unnamed Tributary 2 via a channel, and it is extremely likely that excess water from Ponds 5, 6 and 7 drains to Unnamed Tributary 2 which converges with Unnamed Tributary 1. As stated previously, it is Alt & Witzig's opinion that Unnamed Tributary 1 contains a significant nexus to a "Waters of the U.S."; therefore, Ponds 5, 6 and 7 and the fringe wetland areas are anticipated to be regulated by the USACE as "Waters of the U.S."

Photograph # 9	Description: Viewing Pond 5 located on the eastern portion of the Site.	
Project # 16IN0310	Project Name: 340-Acre Tract	Date: 5/17/2016

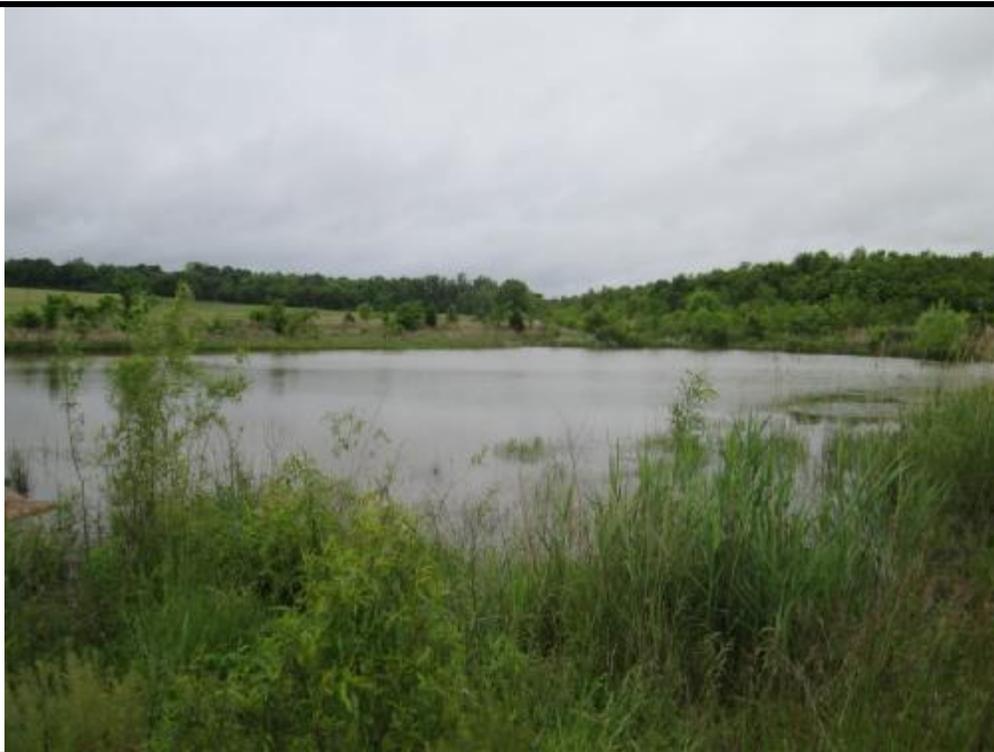
Photograph # 10	Description: Viewing Pond 6 located on the eastern portion of the Site.	
Project # 16IN0310	Project Name: 340-Acre Tract	Date: 5/17/2016
